Manhole Inspection Summary

Manhole # S21E__009MH

Insp Date: **10/15/07 1:32 PM**

Location Address: **1844 SARAH ANN ST**

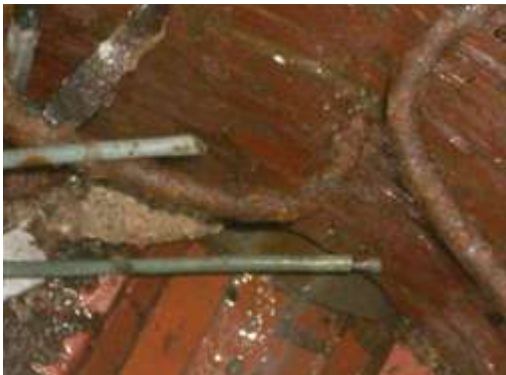
Defect 2

Condition: ☐ Sound ☐ Cracked ☐ Root Intrusion ☐ Deteriorated ☐ Leaks ☒ **Debris**

Steps Count: **5** Missing: **0** ☒ **Corroded**

CORRODED STEPS, DEBRIS ON BENCH

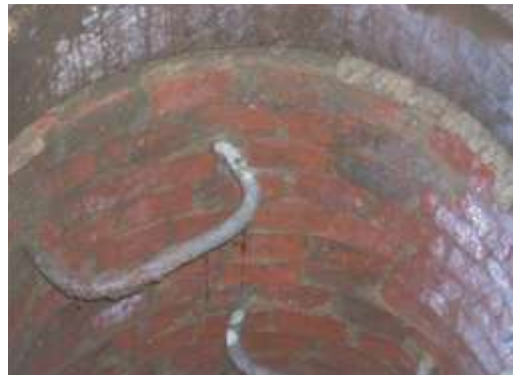
Defect 1

Condition: ☐ Sound ☐ Cracked ☐ Root Intrusion ☐ Loose Brick ☒ **Deteriorated**

CHIMNEY DETERIORATION

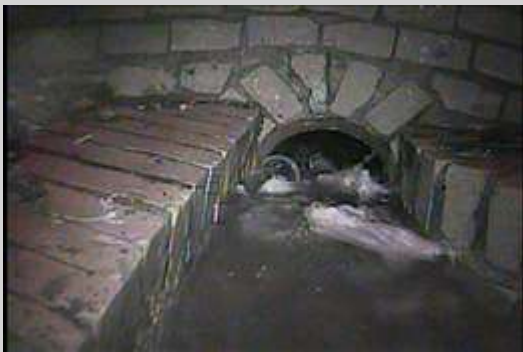
12 O'Clock Outflow

8 in. Circular Gravity Sewer
Pipe Out @ 12 O'Clock

Pipe Height: **7.2** (in.) Rod and Bar (Angled)
Pipe Material: **Clay** ☐ Pipe Lined
Invert Depth: **8.41** (ft.) Flow Characteristics: **Slow**
Deposits: ☐ None ☐ Mud ☒ Sludge ☒ Debris ☐ Grease
Silt Depth: **6** (in.) Deposits Extent: **Heavy**
Infiltration: **None** Pipe Seal Cond: **Sound**

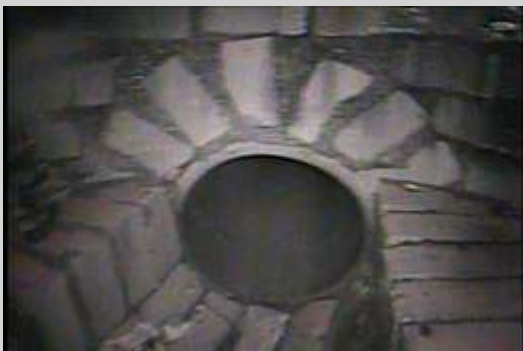
3 O'Clock Inflow

8 in. Circular Gravity Sewer
Pipe In @ 3 O'Clock

Pipe Height: **8.4** (in.) Rod and Bar (Angled)
Pipe Material: **Clay** ☐ Pipe Lined
Invert Depth: **8.02** (ft.) Flow Characteristics: **Slow**
Deposits: ☒ None ☐ Mud ☐ Sludge ☐ Debris ☐ Grease
Silt Depth: (in.) Deposits Extent:
Infiltration: **None** Pipe Seal Cond: **Sound**

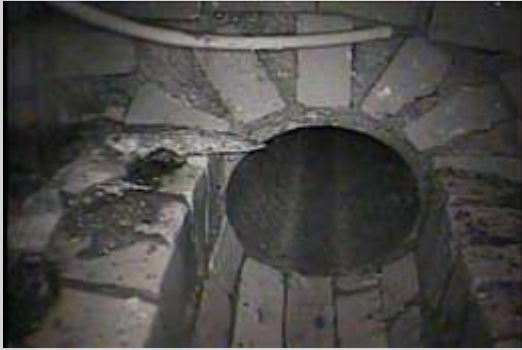
6 O'Clock Inflow

Pipe Height: **8.4** (in.) Rod and Bar (Angled)

Deposits: ☒ None ☐ Mud ☐ Sludge ☐ Debris ☐ Grease

Infiltration: **None** Pipe Seal Cond: **Sound**

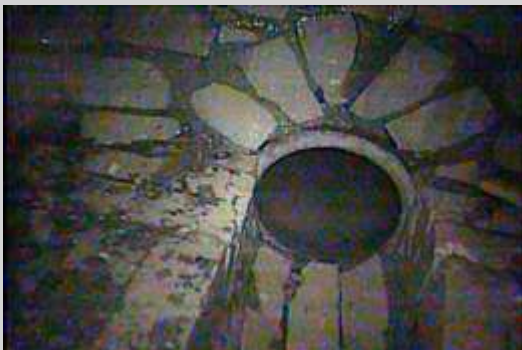
9 O'Clock Inflow

Pipe Height: **6** (in.) Rod and Bar (Angled)

Deposits: ☒ None ☐ Mud ☐ Sludge ☐ Debris ☐ Grease

Infiltration: **None** Pipe Seal Cond: **Sound**
